Woods Engineering, Inc.

March 26, 2025

Subject: **Report of Limited Building Envelope Assessment
Tidesfall Condominium
395 S. Atlantic Avenue
Ormond Beach, Florida
WEI Project 25-1835**

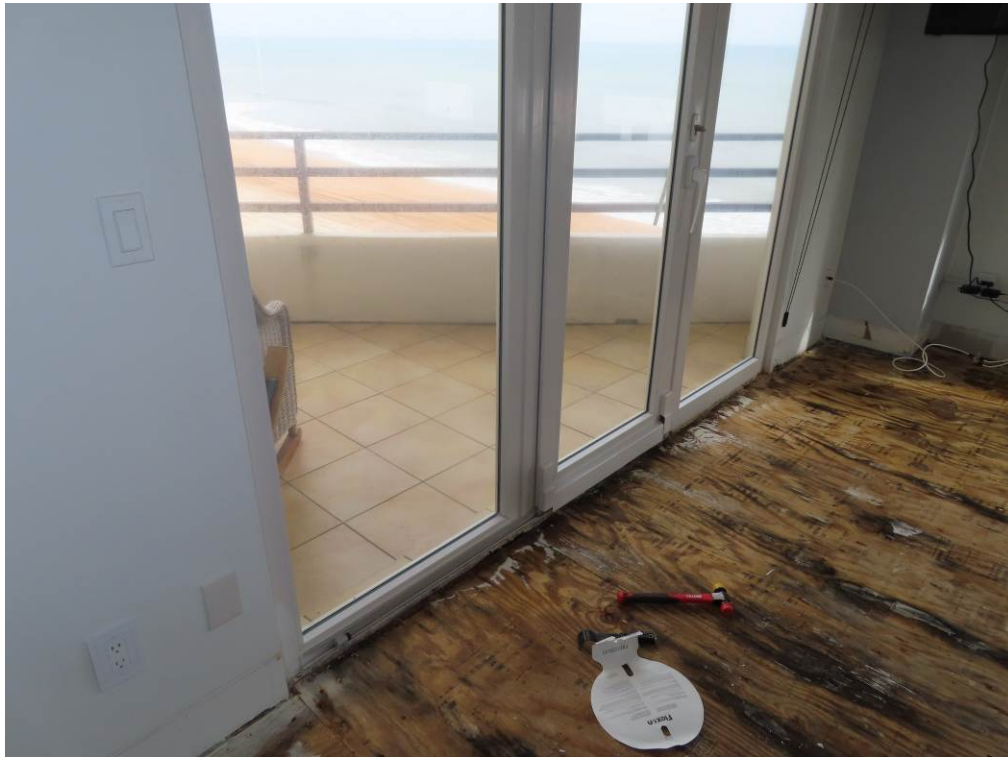
At the time of our visit, the flooring of Unit 406 had been removed adjacent to the northeast facing sliding glass door and the adjacent set of east elevation windows. The wood subfloor showed signs of moisture damage adjacent to the door and under the windows. The window system was observed to consist of fixed and casement style vinyl or vinyl clad windows combined with vertical and horizontal mullions. Weather stripping is provided at two locations of the operable casement sashes. The outer stripping is installed on the frame and seals to the sash. The inner stripping is installed on the operable sash and seals to the inside face of the frame. At the time of our visit the outer stripping appeared moderately deteriorated from UV exposure, but the inner stripping was in good condition. It was reported that Association maintenance has the ability to replace the weather stripping if requested by the unit owner. It appears the inner stripping of the east elevation casement windows of Unit 406 has been recently replaced.

Photograph 1
Unit 406 Flooring Removed and Subfloor Staining at Sliding Door

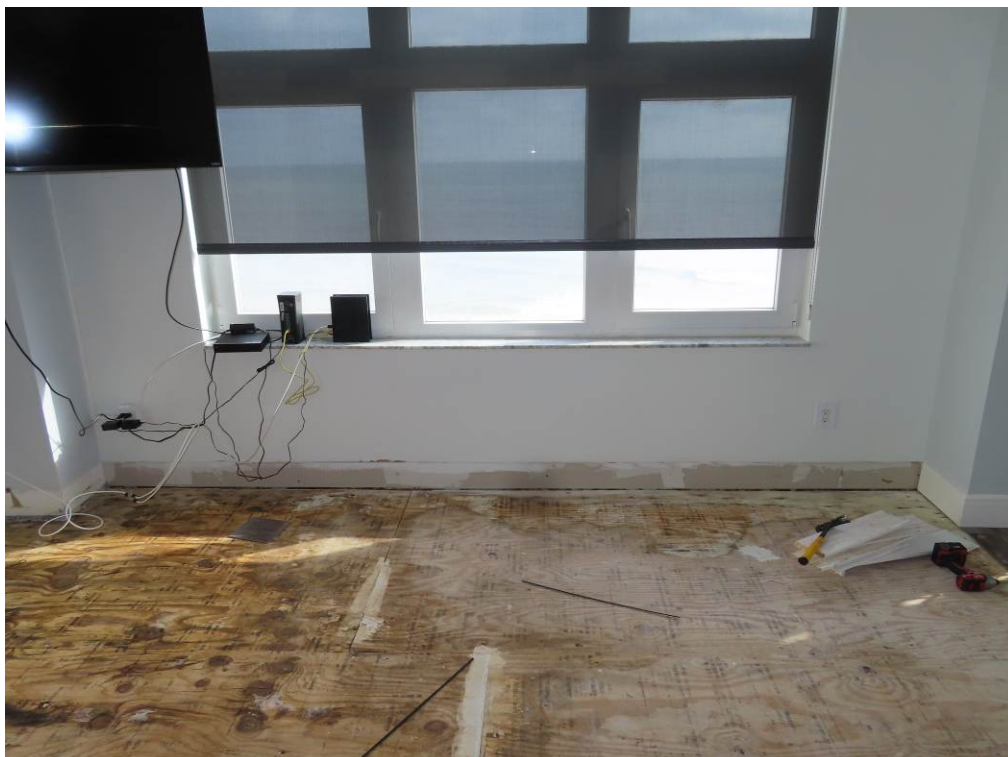
Photograph 2
Unit 406 Flooring Removed and Subfloor Staining under Windows

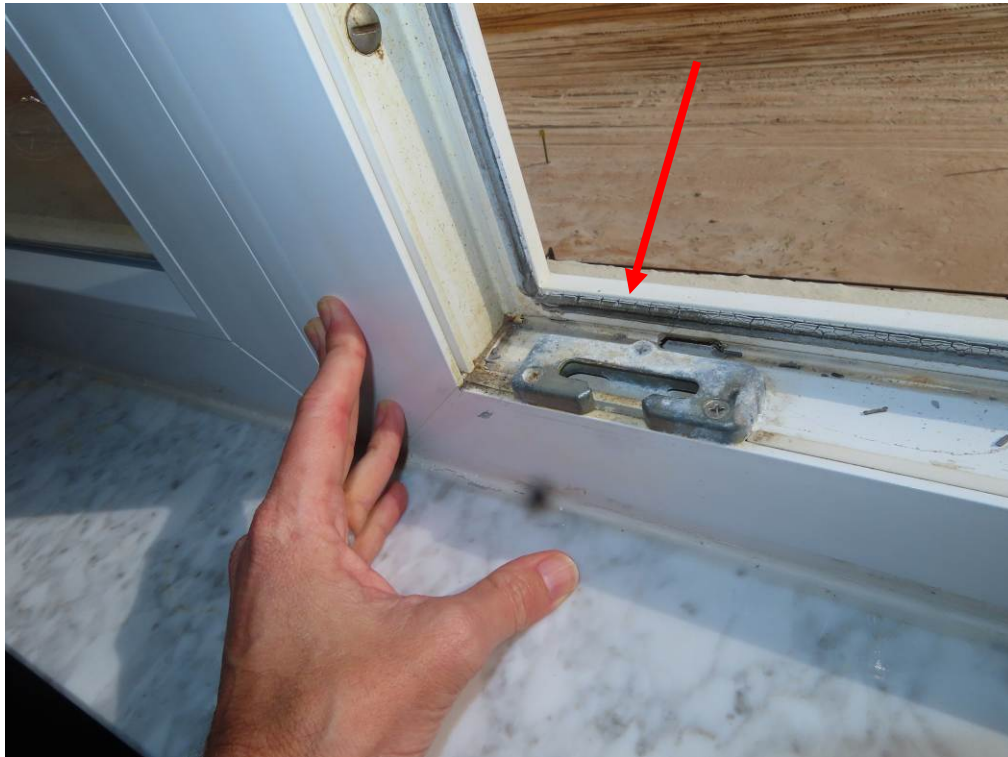
Photograph 3
406 Casement Window Outer Weather Stripping

We recommend continued maintenance of the window and door weather stripping gaskets to include replacement where they are found to be cracked and deteriorated. Building sealants should be removed and replaced during the regularly scheduled painting maintenance work. Where fixed windows include glazing sealants, the glazing sealants should also be removed and replaced.

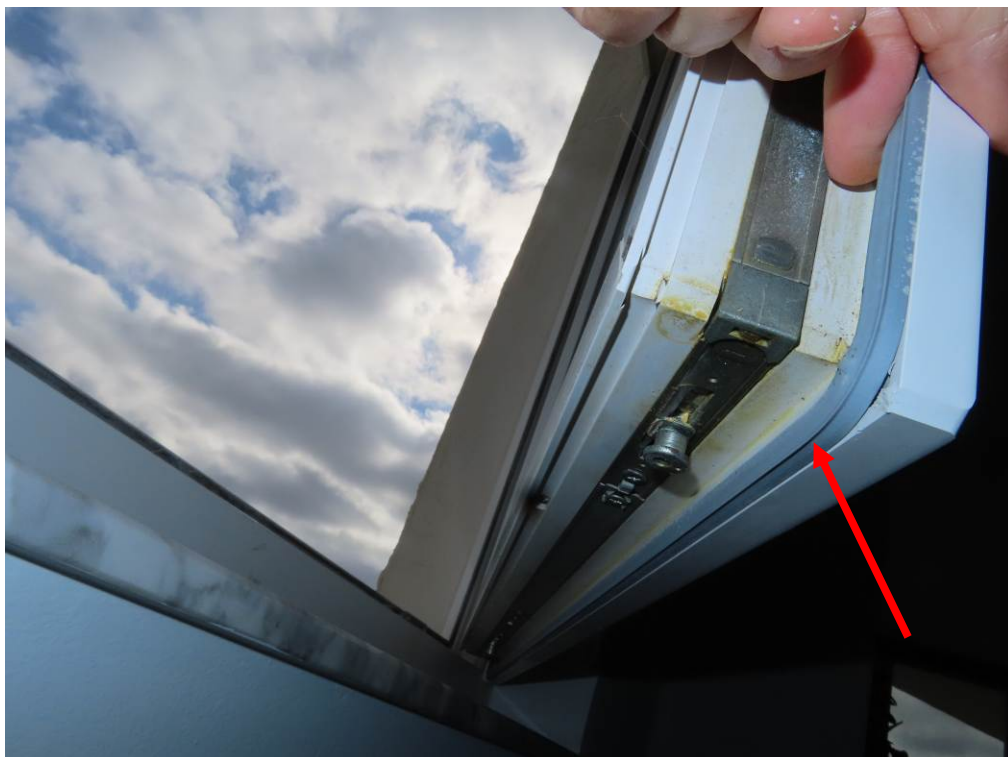
Photograph 4
406 Casement Window Inner Weather Stripping

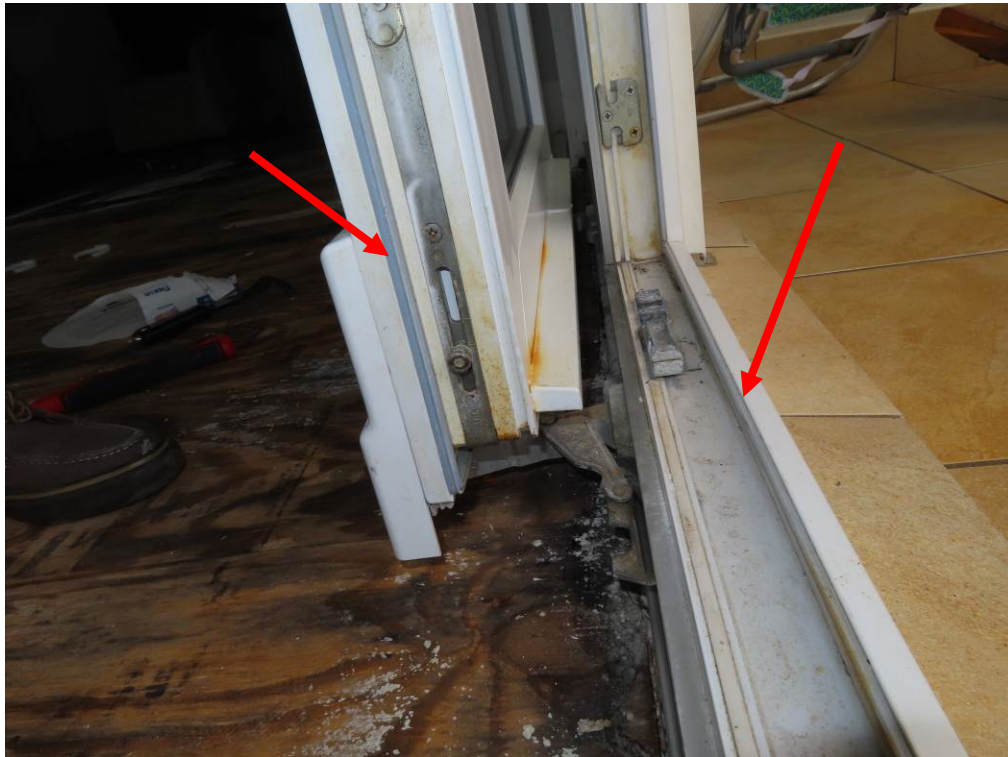
Maintenance personnel reported the doors and windows were manufactured by Roto and were installed on or around 2006. The design of the system relies on compression of the two sets of weather stripping to resist water penetration. The systems require the operable portions to be fully latched to operate properly with respect to water penetration resistance. The interior pane of the glazing provided appears to be impact resistant based on sounding of the material. No labeling or other indicators of the product design pressure were observed.

Photograph 5
Unit 406 Inner and Outer Weather Stripping Indicated

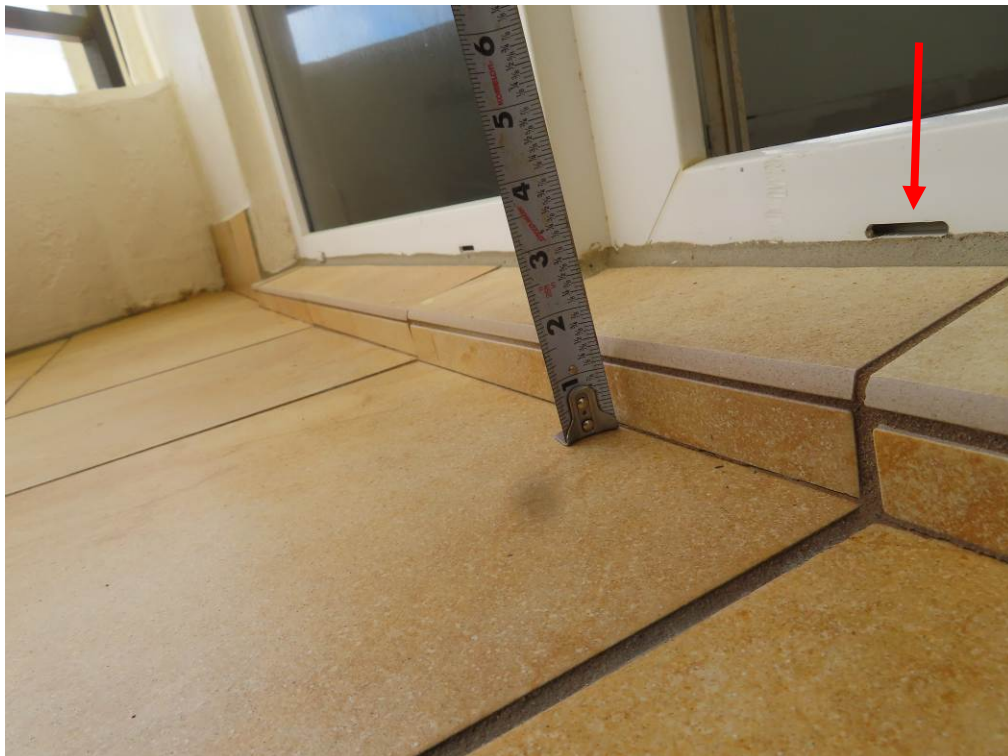
Balcony observations showed the sliding glass doors are installed on an approximately 2-inch curb, sealants are in fair to good condition, and the door weeps are not blocked and appear functional.

Photograph 6
Unit 406 Exterior Door Curb and Sealants, Door Weeps Remain Open

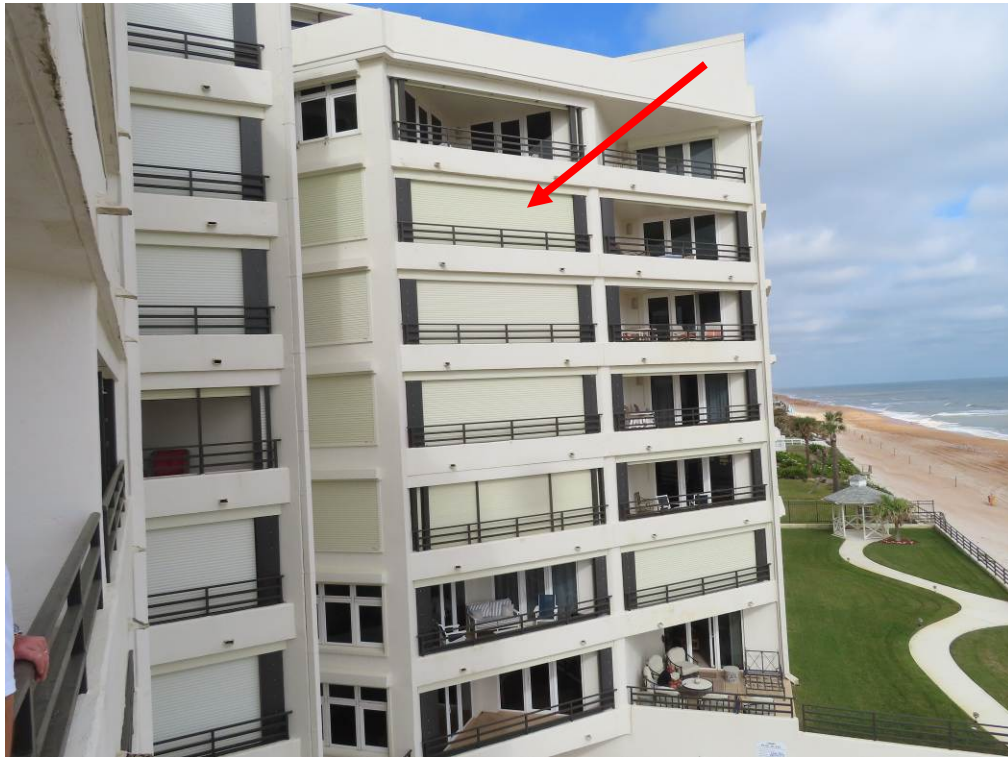
**Photograph 7
Hurricane Shutters Installed on Multiple Units**

Many of the units at Tidesfall were observed to have hurricane shutters installed. It was reported that no water penetration occurs during storm events within the units when the shutters are closed. For the purpose of mitigating water intrusion during high wind events, we recommend installing hurricane shutters on all units and ensuring they are closed during wind events expected to exceed 50 mph.

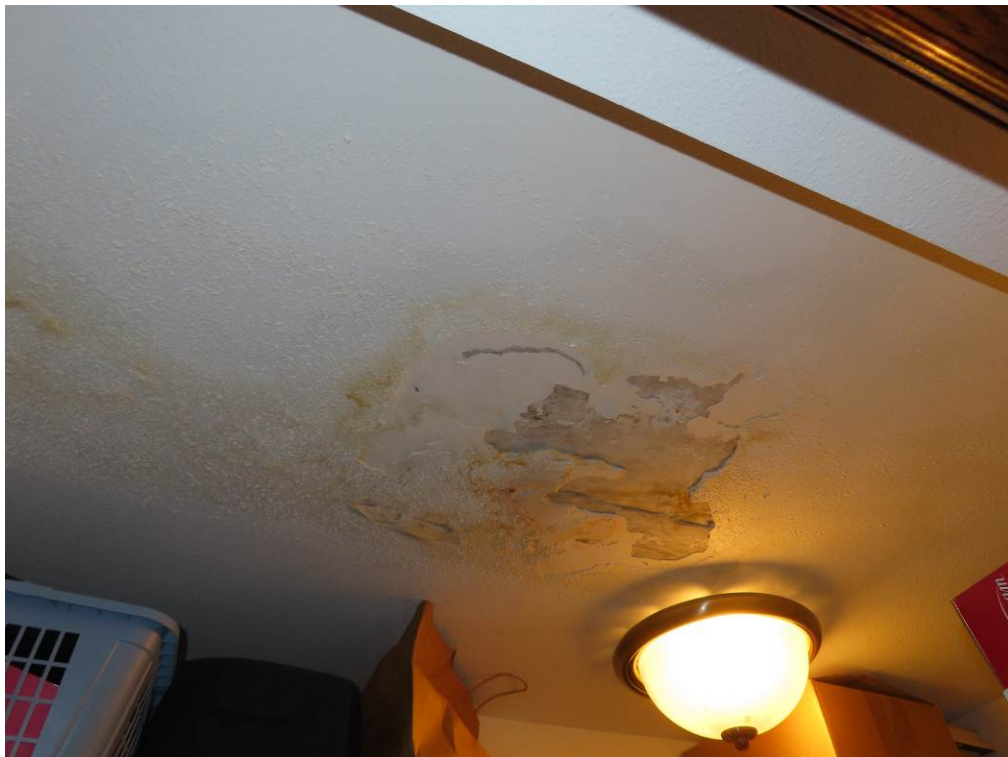
Water intrusion has also been reported within Unit 706 which is a two-story unit. Water intrusion related to conditions at the southeast facing second floor door of the unit has caused damage to nearby closet ceilings of the ground floor of Unit 706 and units below. The liquid applied balcony slab coating adjacent to the door was reportedly replaced approximately two years ago. The weather stripping of the doors in Unit 706 appeared to be in good condition. The water intrusion resulting in the closet damage appears to convey from the southeast door under the flooring materials based on the observable conditions.

**Photograph 8
Unit 706 First Unit Level Closet Ceiling Damage**

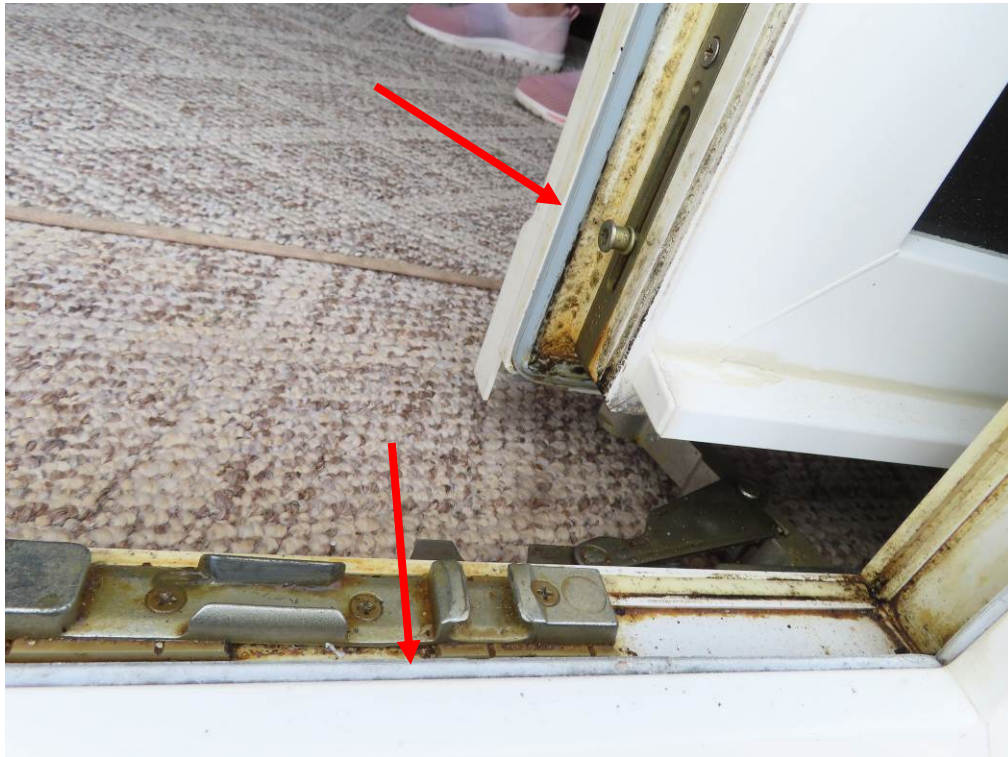
Photograph 9

Unit 706 Upper Level Southeast Door Weather Stripping in Good Condition

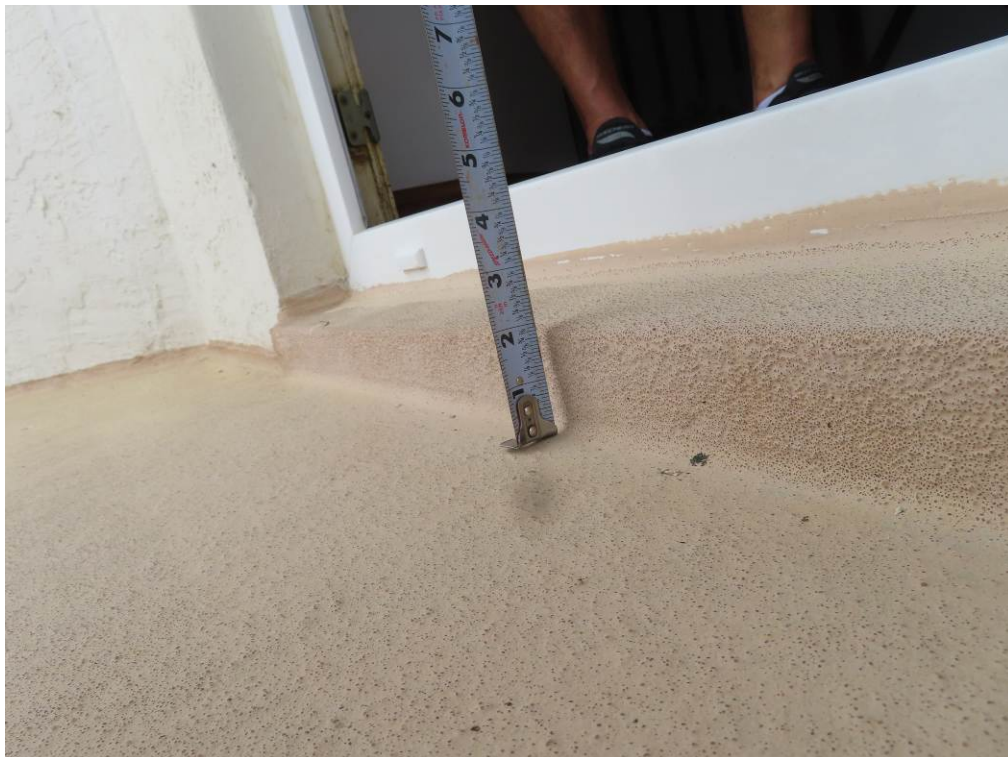
Unit 706 Upper Level Southeast Door Relatively New Deck Coating

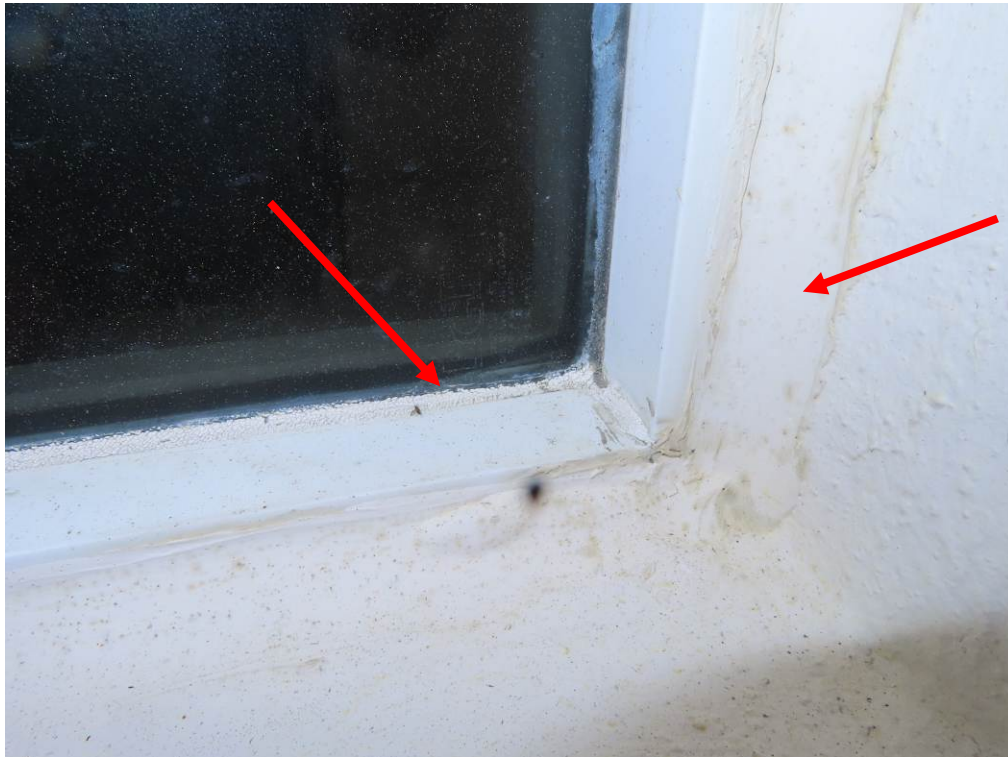
Photograph 11

The direct applied stucco of the walls adjacent to the referenced unit 706 doors appeared to be in fair to good condition with no observable indicators of significant sources of water intrusion. Building sealants (stucco to window and door frames) appeared to be in fair to good condition. The building was last painted approximately six years ago and is scheduled for repainting next year. A fixed and non-operable window on the east elevation near the southeast door was observed to have glazing (glass) sealants in poor condition; however, the water intrusion observed and reported does not appear to be related to the glazing sealant condition.

Unit 706 Upper Level East Elevation Fixed Window Building Sealant in Good Condition, Glazing Sealant in Poor Condition

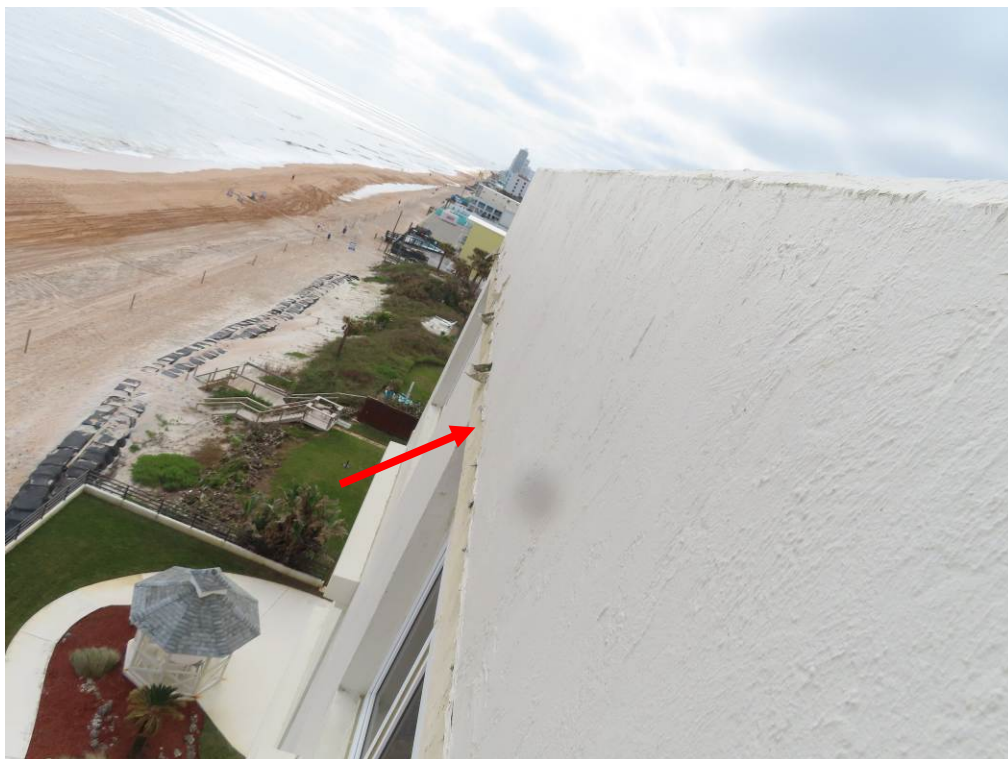
Photograph 12

Gutters installed after original construction for the purpose of collecting water runoff from the Unit 706 upper floor balconies (from through wall scuppers) have become detached due to winds from a prior storm event. A portion of the associated downspout was also observed to be missing.

The failure of the gutter at unit 706 nor the stucco or roof systems appear to be contributing to the water intrusion at units 406 and 706 based on the observable conditions.

Displaced Gutter (Missing) Unit 706 under Scuppers

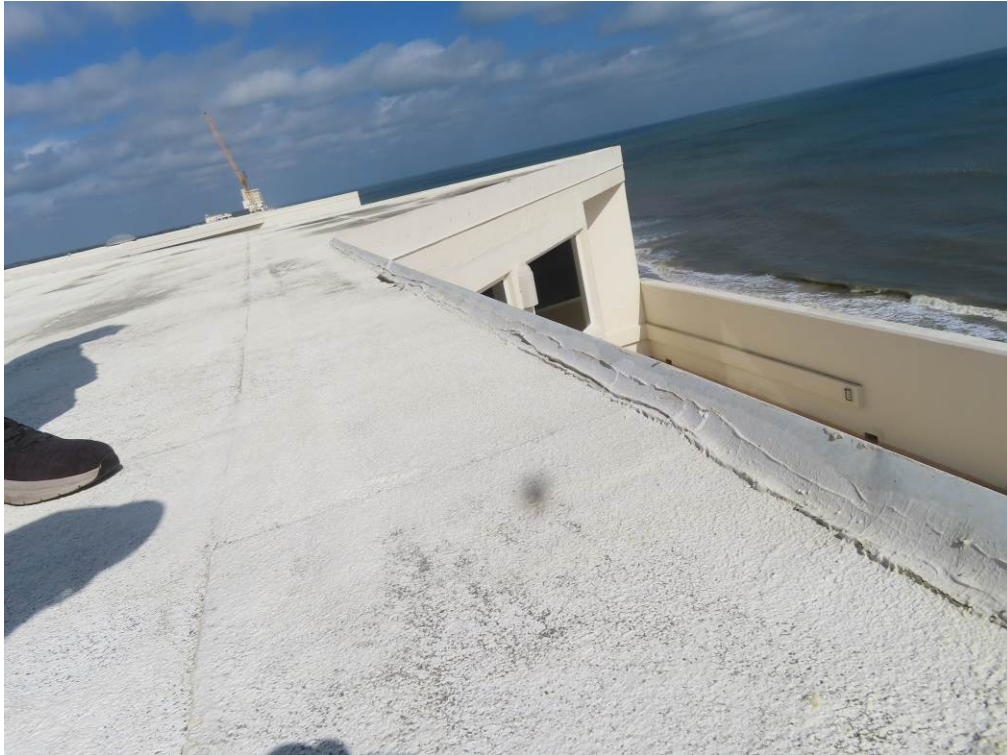
Photograph 13

The roof system above unit 706 was accessed and observed for conditions related to potential water intrusion. No significant observable defects were identified in the roof or roof transitions in the area.

Silicone Coated Modified Bitumen Roof Over 706 in Good Condition

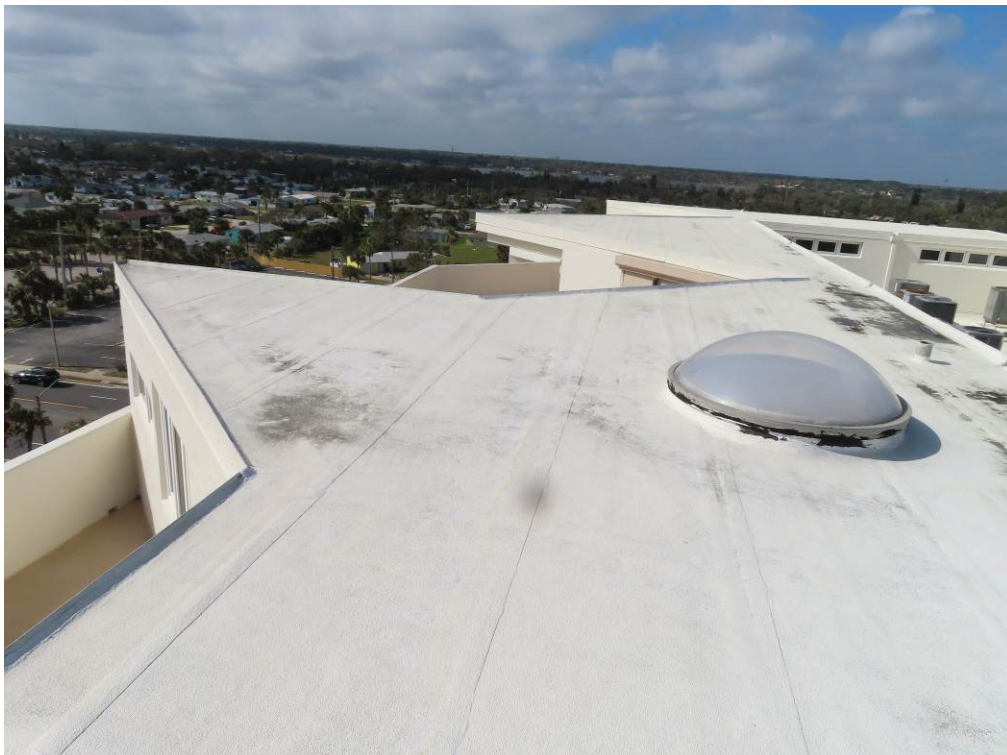
Photograph 14

**Silicone Coated Modified Bitumen Roof Over 706 in Good Condition, No
Leaks Reported at Skylight**
